**USAAVLABS TECHNICAL REPORT 71-9**

**UH-1 AND AH-1 HELICOPTER MAIN ROTOR BLADE FAILURE  
AND SCRAP RATE DATA ANALYSIS**

**EUSTIS DIRECTORATE  
U. S. ARMY AIR MOBILITY RESEARCH AND DEVELOPMENT LABORATORY  
FORT EUSTIS, VIRGINIA**

**CONTRACT DAAJ02-70-C-0016  
BELL HELICOPTER COMPANY  
FORT WORTH, TEXAS**

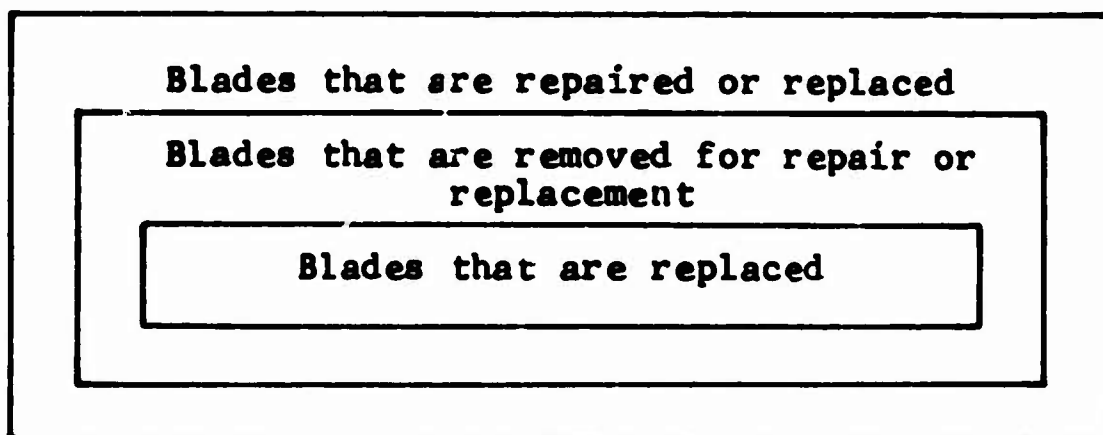
The first set is a subset of the second which is a subset of the third as shown in Figure 1.

Figure 1. Set/Subset Relationship of the M/R Blade Failures Found in the FDR Data.

- Failures that resulted in blade replacement
- Failures that resulted in blade removal for repair or replacement
- Failures that resulted in blade repair (either with blade removed or not removed) or replacement
